Accessibility
Self Evaluation and Transition Plan
Apostle Islands National Lakeshore

Apostle Islands National Lakeshore (APIS) has prepared this Self Evaluation and Transition Plan to ensure we are providing comparable opportunities to experience the park to all visitors, regardless of their abilities. As a public entity, APIS is obligated to ensure that our programs, services and facilities are accessible to all visitors based on *Section 504 of the Rehabilitation Act of 1973* which prohibits discrimination against individuals based on disability.

This report was created after conducting site visits to sites and islands within the park and a review of the programs and interpretive media available to park visitors in the summer of 2011. The following documents were used as the basis for recommendations, some of which are specific to the National Park Service:

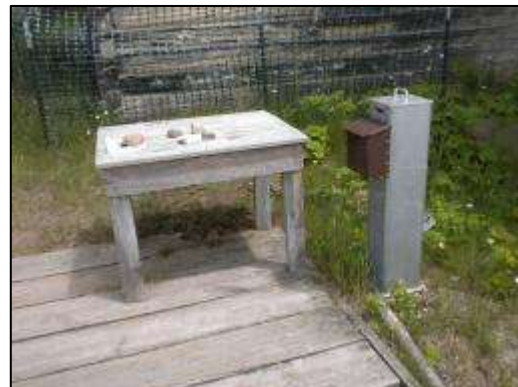
2. APIS Manitou Island. View of fee station. The movable table currently obstructs the approach to the fee station.

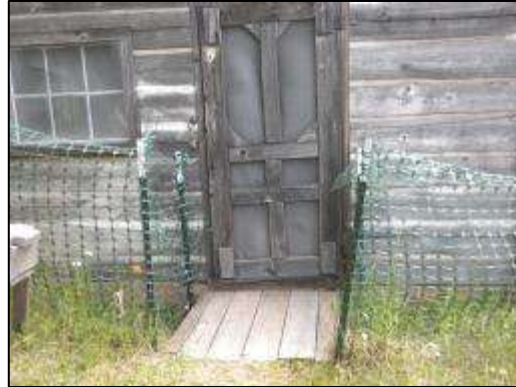
4. APIS Manitou Island. View of Governor's Cabin. Maneuvering clearance is not currently provided on the pull side of the door.

Item	Deficiency	<input type="checkbox"/> Possible Solutions (recommended action indicated by: ►)	Barrier Level	Timeframe
Fish Camp National Register of Historic Places				
Fish Camp-Governor's Cabin	The Governor's Cabin has been staged with period furnishings and is open for the public to enter. There is currently a 3 1/2" vertical rise on the exterior side of the entry door. <i>ABA 303</i>	<ul style="list-style-type: none"> ➤ Reinstall the wood walkway/deck to eliminate the 3 1/2" vertical change. <input type="checkbox"/> Construct a ramp to eliminate the 3 1/2" vertical change. 	2	Short term
Fish Camp-Governor's Cabin	There is currently a 3/4" rise on the interior side of the entry door threshold. <i>ABA 303</i>	<ul style="list-style-type: none"> <input type="checkbox"/> Modify the threshold to eliminate the 3/4" rise. ➤ Add a threshold adapter to eliminate the 3/4" rise. 	2	Short term
Fish Camp-Governor's Cabin	Maneuvering clearance is not currently provided on the exterior side of the entry door. <i>ABA 404</i>	<ul style="list-style-type: none"> ➤ Enlarge the walkway/deck to extend a minimum of 18" beyond the latch side of the door. 	2	Long term

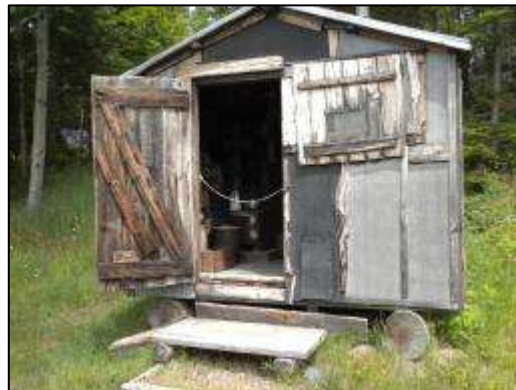
6. APIS Manitou Island. View of twine shed #5. Visitors can view into the twine shed, but are not allowed to enter.

Fish Camp-Twine Shed #6	There is not currently an accessible route into Twine Shed #6 which has been staged with period artifacts. There is a total of an 18" rise into the building. <i>ABA F206.2</i>	<ul style="list-style-type: none"> ➤ No action. The shed can be viewed from the exterior. <input type="checkbox"/> Discontinue allowing visitors into the shed. 	1	Long term
Fish Camp-Route	The route throughout the Fish Camp is grass, sand and compacted dirt. <i>ABA F206.2</i>	<ul style="list-style-type: none"> ➤ Modify to provide a firm, stable route throughout the Fish Camp and connect to the trailhead (subject to SHPO approval). 	2	Long term
Picnic Area	A picnic area with 2 picnic tables and a fire ring located up the hill from the Fish Camp. The picnic tables do not currently provide knee and toe clearance. <i>Draft Accessibility Guidelines for Outdoor Developed Areas 1011.4</i>	<ul style="list-style-type: none"> ➤ Add an accessible picnic table at an accessible location. <input type="checkbox"/> Replace the existing picnic table with a style that provides knee and toe clearance and is located on an Outdoor Recreation Access Route (ORAR). 	2	Long term

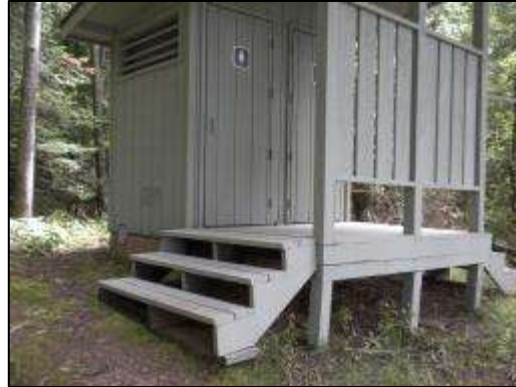
10. APIS Manitou Island. View of double vault toilet.

Vault Toilets	There is a double vault toilet, currently no features of accessibility are provided. <i>ABA F213.2</i>	➤ Replace the existing vault toilet with an accessible style at an accessible location (subject to SHPO approval). <input type="checkbox"/> Add an additional accessible vault toilet.	1	Long term
Trail	There is an approximately 2 mile trail from the dock to the campsite. The trail surface is narrow, has tree roots and rocks and has steep segments. The trail is located in the Gaylord Nelson Wilderness <i>Draft Accessibility Guidelines for Outdoor Developed Areas F247</i>	➤ No action. The trail is within the Gaylord Nelson Wilderness.	1	Long term
Trailhead Sign	The sign at the trailhead does not currently include information about the characteristics (width, slope, cross slope, etc.) of the trail. <i>Draft Accessibility Guidelines for outdoor Developed Areas 1017.11</i>	➤ At such time the trailhead sign is replaced, provide additional information about the characteristics of the trail.	3	Long term

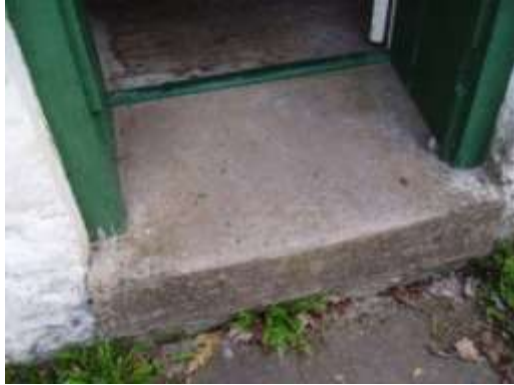
7. APIS Michigan Island. The Old Michigan Island Lighthouse main entry is not currently accessible.

Entry	The clear opening of main entry door is currently 29". ABA 404.2.3	<input type="checkbox"/> Remove and replace the door with a style that provides a 32" minimum clear opening. ➤ Remove the trim/stop to get a 30 3/4" clear opening up to wheelchair height.	3	Short term
Door Hardware	The operable door hardware at the main entry to the Old Lighthouse is currently a knob style. ABA 309.4	<input type="checkbox"/> Replace the knob style hardware with a style that does not require tight grasping, pinching or twisting of the wrist to operate (such as a lever). ➤ Prop doors in the open position when the Old Lighthouse is open to the public, eliminating the need to use the knob style hardware.	2	Short term
Interior Doors	The clear opening of the interior doors is currently 31" at the living room and kitchen, 29" to the former bathroom*. *The bathroom door is not intended for user passage, it will be held in the open position to allow for light. ABA 404.2.3	<input type="checkbox"/> Remove and replace the door with a style that provides a 32" minimum clear opening. ➤ Remove the door.	3	Short term

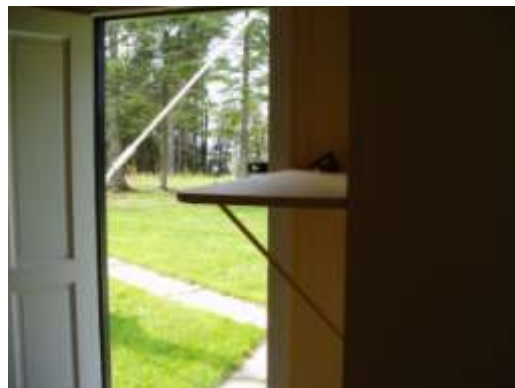
12. APIS Michigan Island Second Tower. Protruding shelf near entry.

Entry	There is currently a 2" vertical rise at the threshold of the entry door. <i>ABA 404.2.5</i>	➤ Address the vertical rise at such time a ramp is added.	2	Long term
Interior-Shelf	There is currently a shelf inside the main level of the Second Tower near the entry door that protrudes 16" at a height of 54 1/2". <i>ABA F204.1, 307</i>	<input type="checkbox"/> Position an object below the shelf so it is no longer a protruding hazard. (The object will obstruct the maneuvering clearance at the door.) ➤ Remove the shelf.	2	Short term
Vault Toilet				
Vault Toilet	The vault toilet does not currently provide any features of accessibility.	➤ Replace the existing vault toilet with an accessible style. <input type="checkbox"/> Add an additional, accessible vault toilet.	1	Short term
Vault Toilet-Route	There is not currently an accessible route to the vault toilet. <i>ABA F206.2</i>	➤ Create an accessible route to the vault toilet from the light station.	2	Short term

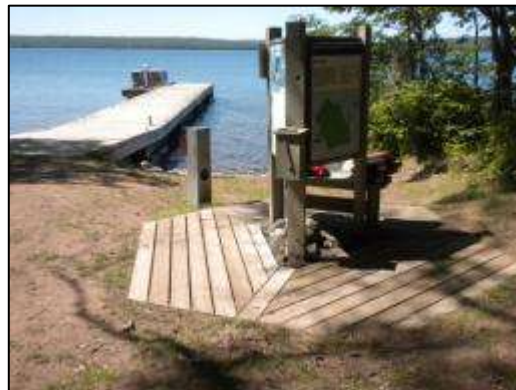
2. APIS Oak Island. Waysides near the dock. A wood deck has been created around the waysides and brochure box. There is not currently a route that connects the dock to the waysides.

Waysides	<p>A 3 panel wayside with a brochure box is positioned on shore near the end of the dock. There is a hexagon shaped 'deck' that surrounds the waysides. The route between the end of the dock and the waysides is currently compacted dirt. A firm and stable surface is not currently provided.</p> <p><i>Draft Accessibility Guidelines for Outdoor Developed Areas F244.5</i></p>	➤ Create a firm and stable surface to connect the dock to the waysides.	2	Long term
Route	<p>The route from the dock to campsites B, 2 and 3 is a compacted dirt trail. The route is steepest near the dock, where water diverters / stairs have been created.</p> <p><i>Draft Accessibility Guidelines for Outdoor Developed Areas F247</i></p>	➤ At such time a new trail is created, ensure it is accessible.	1	Long term
Picnic Area	<p>A day use picnic area with 1 picnic table and a fire ring is currently located near campsites 2 and B. The picnic table does not currently provide knee and toe clearance.</p> <p><i>Draft Accessibility Guidelines for Outdoor Developed Areas 1011.4</i></p>	<input type="checkbox"/> Add an accessible picnic table. ➤ Replace the existing picnic table with a style that provides knee and toe clearance.	2	Long term

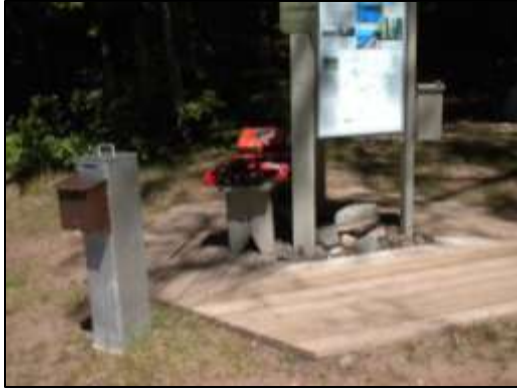
3. APIS Oak Island. Fee station. The fee station is currently positioned so the slot is opposite the wood deck provided around the waysides.

Item	Deficiency	<input type="checkbox"/> Possible Solutions (recommended action indicated by: ►)	Barrier Level	Timeframe
Fee Station	The fee station is positioned near the dock, adjacent to the waysides. The slot of the fee station is currently facing the opposite direction from the edge of the 'deck' surrounding the waysides. ABA 305	<input type="checkbox"/> Relocate the fee station so it is positioned on an accessible route (possibly on the dock). ► Rotate the fee station one hundred eighty degrees (180°) in its existing location so the slot is within reach from the 'deck' surrounding the wayside.	3	Long term

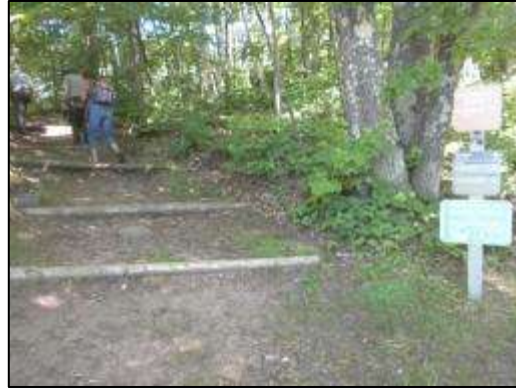
4. APIS Oak Island. Route from dock to campsites 2-3. Timbers have been installed for water diversion due to the steep slope.

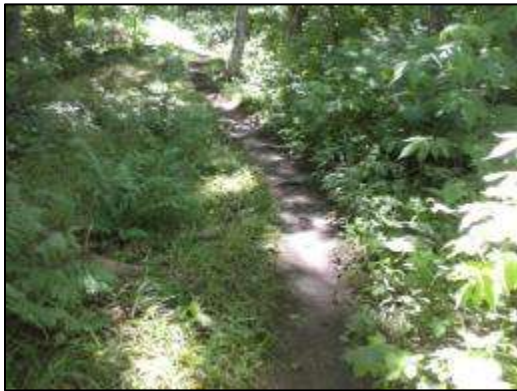
5. APIS Oak Island. Typical trail surface is compacted dirt.

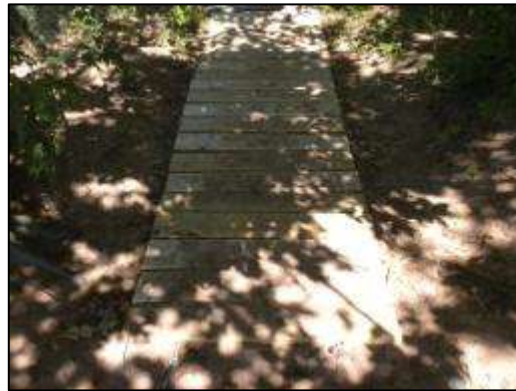
6. APIS Oak Island. Boardwalk to campsite 1.

Campsites- routes	Campsite 1 is located on the sandspit and has access directly from the beach. A boardwalk has been provided to connect the sand beach to the campsite. The boardwalk is 32" wide at the entry point, and 36" wide elsewhere. <i>Draft Accessibility Guidelines for Outdoor Developed Areas 1016.3</i>	<input type="checkbox"/> At such time the boardwalk is replaced, ensure it is 36" wide minimum. ➤ No action. This campsite is located within the Gaylord Nelson Wilderness.	2	Long term
Group Campsites- A and B	Picnic tables (5 at A, 2 and B), fire ring and bear locker are provided at each of the group campsites. The picnic tables do not currently provide knee and toe clearance. <i>Draft Accessibility Guidelines for Outdoor Developed Areas 1011.4</i>	<input type="checkbox"/> Replace the existing picnic table with a style that provides knee and toe clearance at campsite B. ➤ No action. Provide accessible group camping at an alternate location (such as Sand Island or Stockton Island Quarry Bay).	2	Short term

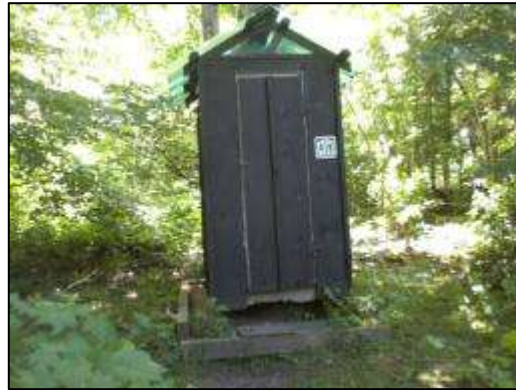
12. APIS Oak Island. Typical vault toilet.

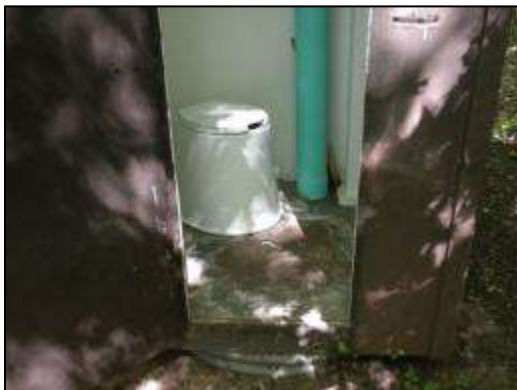
13. APIS Oak Island. typical vault toilet.

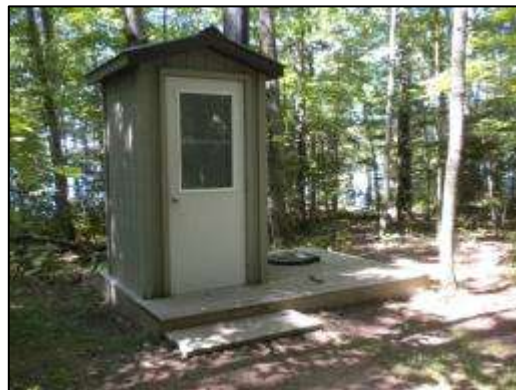
14. APIS Oak Island. Newer vault toilet near campsite 2.

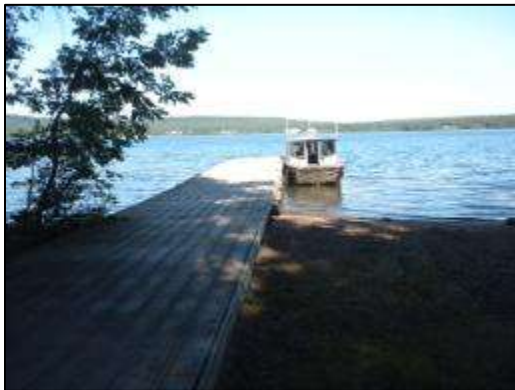
1. APIS Basswood Island. View of dock. (See photo 10 for view of new dock.)

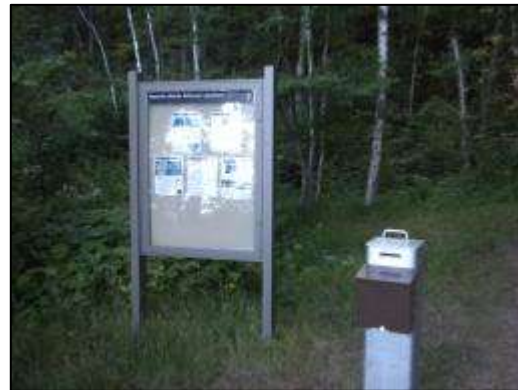
Item	Deficiency	<input type="checkbox"/> Possible Solutions (recommended action Indicated by: ►)	Barrier Level	Timeframe
Fee Station and Waysides	There is a fee station and bulletin case located in the sand near the end of the dock. <i>HFC Programmatic Accessibility Guidelines</i>	<input type="checkbox"/> Add an Outdoor Recreation Access Route and approach to the fee station. ► Relocate the fee station to an accessible location (possibly the dock).	3	Short term
Waysides	There is a wayside panel located along the trail near the Brownstone Quarry. At the time of site visit there was no information on the panel. <i>HFC Programmatic Accessibility Guidelines</i>	► Create a firm, stable surface to approach the wayside at such time content is added to the sign.	2	Long term

2. APIS Basswood Island. View of fee station and wayside, currently located in the grass and sand.

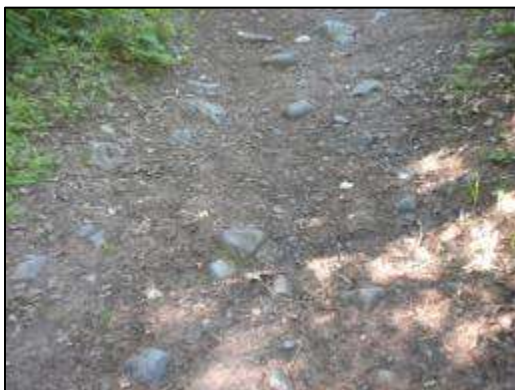
3. APIS Basswood Island. View of trail surface.

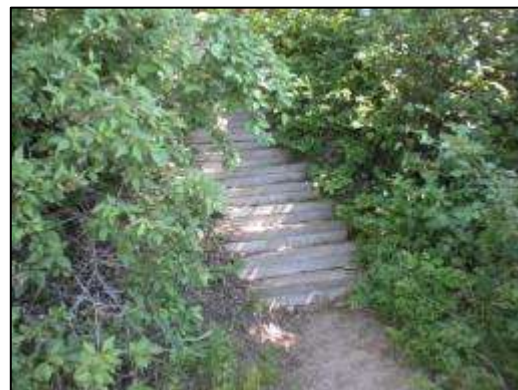
4. APIS Basswood Island. View of route to camping from South Landing.

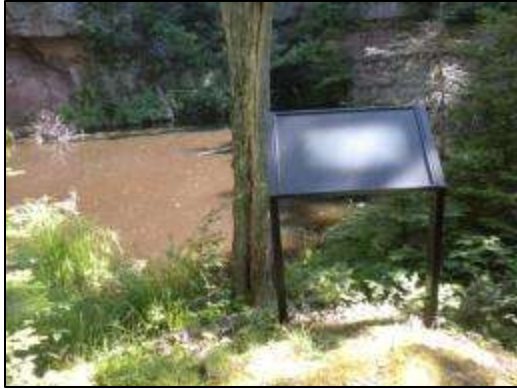
5. APIS Basswood Island. View of wayside near quarry.

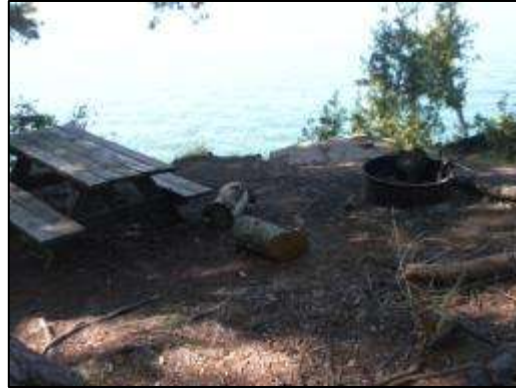
6. APIS Basswood Island. View of typical campsite, including picnic table and fire ring.

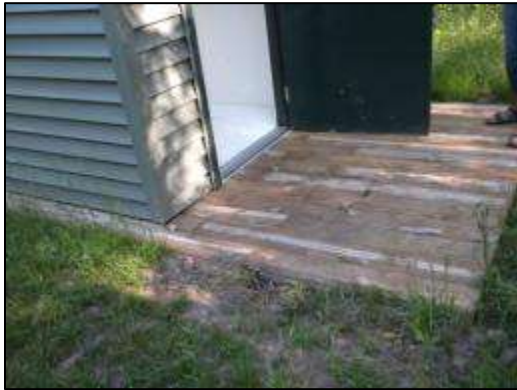
Vault toilets	<p>There are 2 vault toilets. Both of the vault toilets are a newer style that provides features of accessibility, including grab bars, clearances and a wide door with lever style hardware. Currently there are 5 steps up to the toilet serving sites 1-4 and there is a 2" vertical change in elevation at the toilet serving sites 5-6, A.</p> <p><i>ABA F213.2</i></p>	<p>➤ Construct a ramp to create an accessible route to the toilet near sites 1-4.</p> <p>☐ Build up surface material around the location near sites 5-6, A to eliminate the 2" change in level.</p>	2	Long term
---------------	--	---	---	-----------

7. APIS Basswood Island. View of entry in to vault toilet (near group site A).

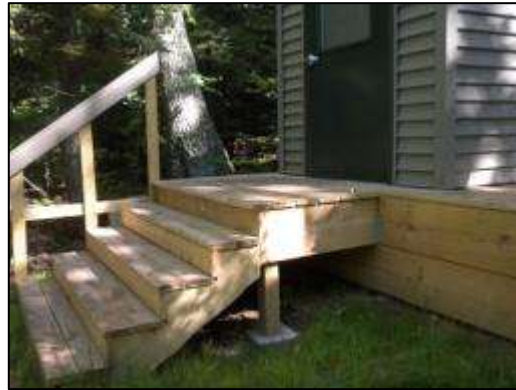
8. APIS Basswood Island. View of entry to vault toilet (near sites 1-4).

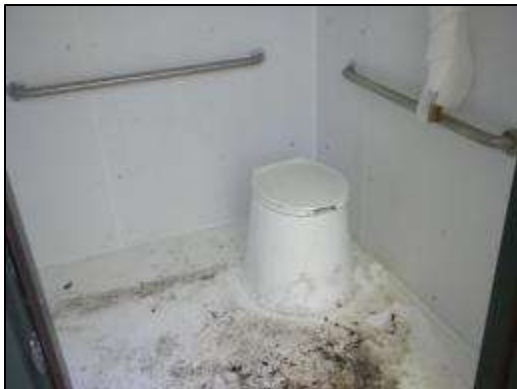
9. APIS Basswood Island. View of interior of vault toilet.

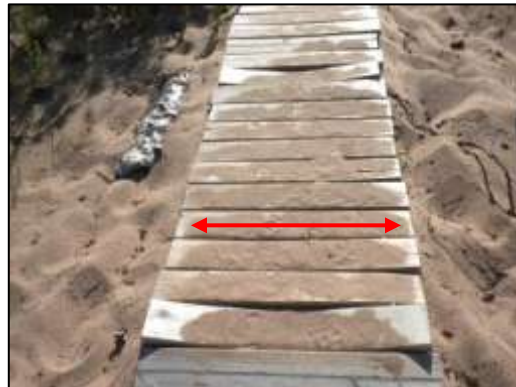
Item	Deficiency	□ Possible Solutions (recommended action indicated by: ►)	Barrier Level	Timeframe
Boardwalk	A boardwalk has been provided as part of the route to the campsite and privy, beginning at the vegetation line. The boardwalk is 32" wide. <i>Draft Accessibility Guidelines for Outdoor Developed Areas 1016.3</i>	□ At such time the boardwalk is replaced or if additional segments of boardwalk are added, ensure it is 36" wide minimum. ► No action. The boardwalk is located within the Gaylord Nelson Wilderness.	1	Long term
Campsite	A fire ring and bear locker are the only amenities provided at the campsite.	► No action. This campsite is located within the Gaylord Nelson Wilderness.	3	Long term
Moldering Privy- route	A moldering privy is provided near the campsite. The privy is raised 31" (must be raised to function correctly). <i>ABA F206.2</i>	□ Install a ramp to eliminate the 31" rise. ► No action. This privy is located within the Gaylord Nelson Wilderness.	1	Long term

2. APIS Cat Island. The boardwalk is currently 32" wide.

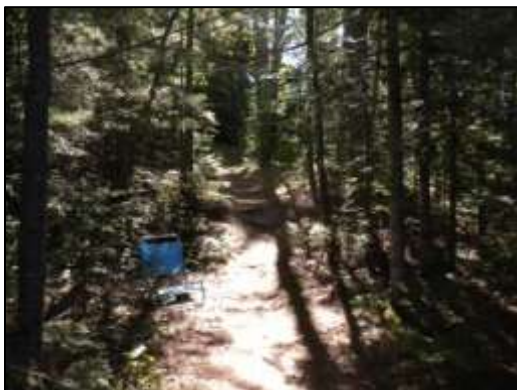
3. APIS Cat Island. View of route to the campsite.

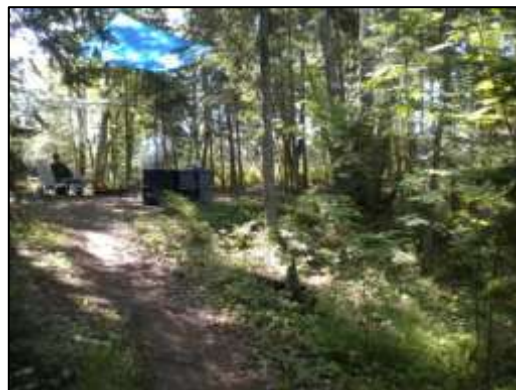
4. APIS Cat Island. View of campsite at Cat Island. Amenities provided include a bear locker and fire ring.

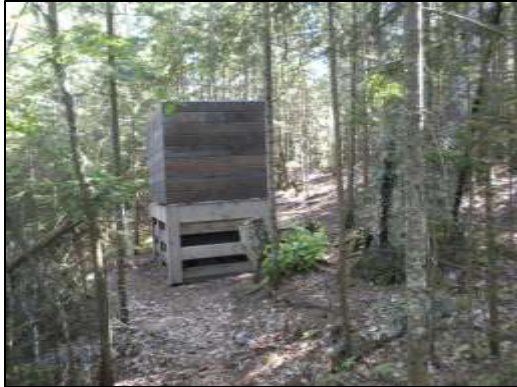
Moldering Privy- route	There is not currently an accessible route to the moldering privy. The current route is sand and segments of 32" wide boardwalk. <i>ABA F206.2</i>	<input type="checkbox"/> Create an accessible route to the moldering privy. ➤ No action. This privy is located within the Gaylord Nelson Wilderness.	1	Long term
Moldering Privy	The existing moldering privy does not currently provide any features of accessibility. The privy is 4' wide x 8' deep. <i>ABA F213.2</i>	<input type="checkbox"/> Replace the existing privy with an accessible style. ➤ Modify the existing privy to provide features of accessibility, including grab bars. <input type="checkbox"/> Add an additional accessible privy. <input type="checkbox"/> No action. This privy is located within the Gaylord Nelson Wilderness.	1	Long term

5. APIS Cat Island. View of moldering privy and route to privy.

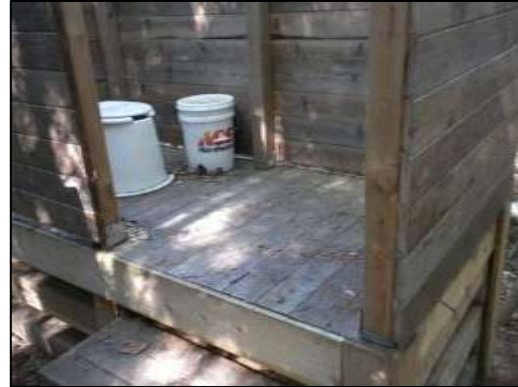
6. APIS Cat Island. View of interior of the moldering privy.

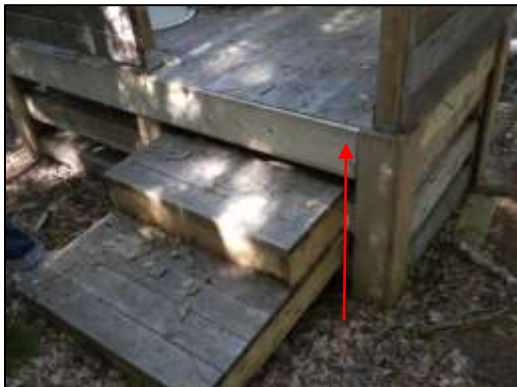
7. APIS Cat Island. There is a 31" rise from the ground surface to the privy. The privy needs to be raised to allow for air circulation in order to function properly.

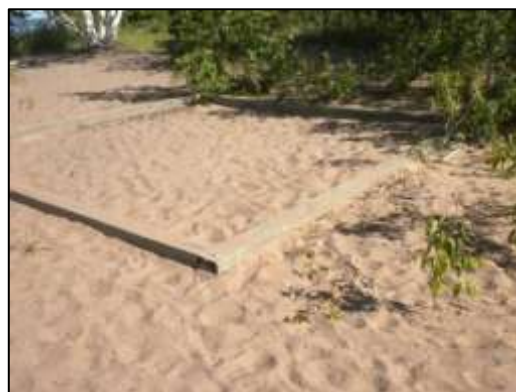
Item	Deficiency	□ Possible Solutions (recommended action indicated by: ►)	Barrier Level	Timeframe
Campsite route	There are currently sand social trails from the beach to the campsite. <i>Draft Accessibility Guidelines for Outdoor Developed Areas F244.5</i>	► No action. The campsite is located within the Gaylord Nelson Wilderness.	1	Long term
Campsite	A picnic table, tent pad, fire ring and bear locker are provided at the campsite. The picnic table does not currently provide knee and toe clearance. <i>Draft Accessibility Guidelines for Outdoor Developed Areas 1016.3</i>	► No action. The campsite is located within the Gaylord Nelson Wilderness. Picnic tables are not typically provided within wilderness campsites.	2	Long term

2. APIS Ironwood Island. View of tent pad at campsite. The ground surface within the campsite is sand.

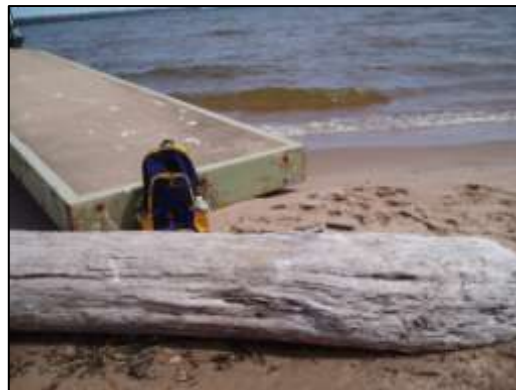
Item	Deficiency	□ Possible Solutions (recommended action indicated by: ►)	Barrier Level	Timeframe
Dock: The dock is located at the northwest end of Long Island near the LaPointe Light Tower. The dock is currently 5' wide and 80' long.				
Dock	There is not currently an accessible route to the island from the dock. The dock currently ends in soft sand. ABA 1003.2, 401	► Create an accessible route to the island from the dock.	1	Long term
Route	There is not currently an accessible route from the site arrival point to the light station. There are sand dunes between the dock and the light station. Approximately 150' of 32" wide boardwalk is provided. ABA F206.2	► Create an accessible route from the dock to the light station by replacing and adding boardwalk.	1	Long term
Triplex: The Triplex is a former residence. It is currently boarded up. Qualified Historic Structure				
Triplex	There is currently a 6" rise to the side entry. ABA F206, 303	<input type="checkbox"/> Construct a ramp with a 1:12 maximum slope. Include required handrails and edge protection. <input type="checkbox"/> Construct a 'ramp' with a 1:20 maximum slope. ► No action at this time, this building is not currently used.	1	Long term

2. APIS Long Island Dock. Currently ends in the sand.

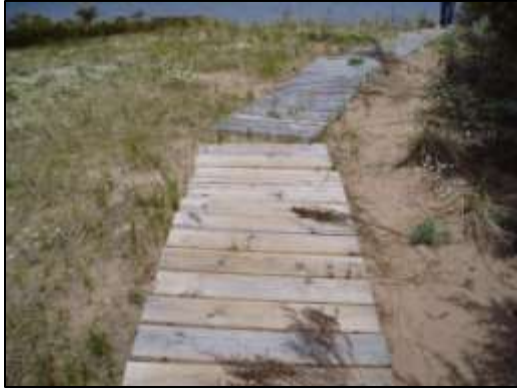
3. APIS Long Island. Boardwalk. View of boardwalk. The sections of boardwalk do not currently cover the entire distance from the dock to the light station.

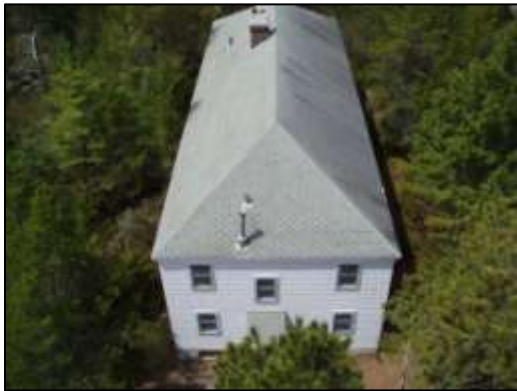
5. APIS Long Island. Triplex.

Triplex- Door Width	The clear opening of side entry door is currently 29 3/4". ABA 404.2.3	<input type="checkbox"/> Remove and replace the door with a style that provides a 32" minimum clear opening. ► No action at this time, this building is not currently used.	3	Long term
Triplex- Door Hardware	The operable door hardware at the side entry is currently a knob style. ABA 309.4	<input type="checkbox"/> Replace the knob style hardware with a style that does not require tight grasping, pinching or twisting of the wrist to operate (such as a lever). ► No action at this time, this building is not currently used.	2	Long term

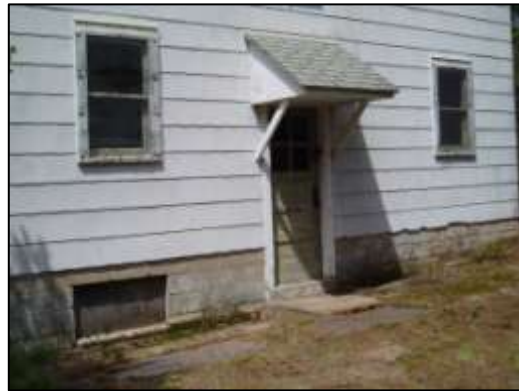
6. APIS Long Island. Triplex. There is not currently an accessible entry.

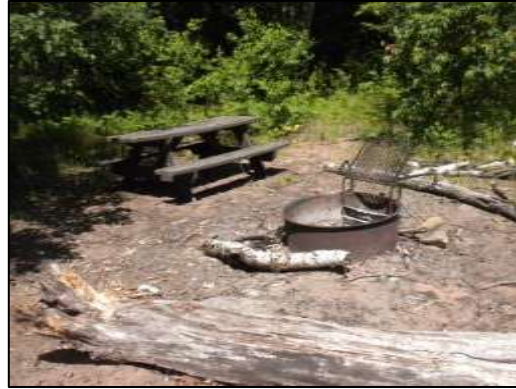
4. APIS Otter Island. A picnic area with a table and a fire ring is provided near the end of the dock.

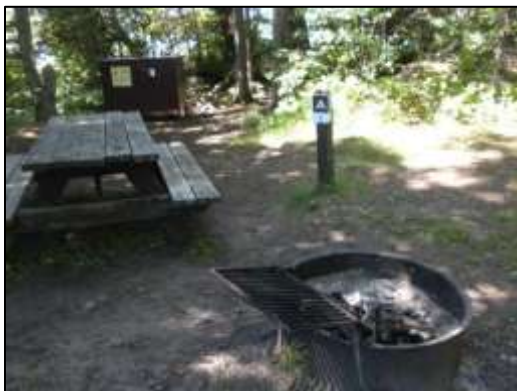
Campsite	A picnic table, fire ring and bear locker are provided at the campsite. The picnic table does not currently provide knee and toe clearance. <i>Draft Accessibility Guidelines for Outdoor Developed Areas 1011.4</i>	► Replace the existing picnic table with a style that provides knee and toe clearance.	2	Short term
Campsite	The surface within the campsite is mostly flat with some tree roots and rocks within the circulation space. <i>Draft Accessibility Guidelines for Outdoor Developed Areas 1016.2</i>	► Clear the tree roots and rocks from the ground surface within the campsite to create a firm, stable surface.	2	Short term
Vault toilet	The existing vault toilet does not currently provide any features of accessibility. It is 38" wide x 48" deep and provides a 24 1/2" clear door opening. <i>ABA F213.2</i>	► Replace the existing vault toilet with an accessible style. <input type="checkbox"/> Add an additional accessible vault toilet.	2	Long term

5. APIS Otter Island. View of campsite. Campsite amenities include a table, fire ring and bear box. The site is mostly flat with a compacted surface.

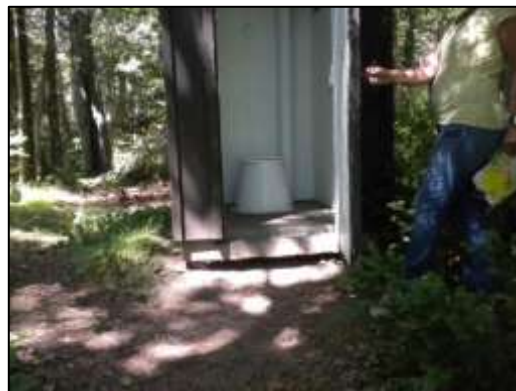
Vault toilet-route	There is currently a 12" vertical rise up to the vault toilet. <i>Draft Accessibility Guidelines for Outdoor Developed Areas 1016.5</i>	<input type="checkbox"/> Add a ramp to eliminate the 12" rise. <input type="checkbox"/> Build up the ground material around the vault toilet to eliminate the 12" rise. ➤ At such time the vault toilet is replaced, ensure there is no vertical rise.	1	Long term
Vault toilet-route	There is not currently an accessible route to the vault toilet. The current route includes a short section of boardwalk. <i>ABA F206.2</i>	<input type="checkbox"/> Create an accessible route to the vault toilet. ➤ At such time the vault toilet is replaced, ensure an accessible route is provided.	2	Long term
Trailhead-Sign	There is a sign at the trailhead indicating the distance to the North Overlook. The sign does not currently include information about the characteristics (width, slope, cross slope, etc) of the trail. <i>Draft Accessibility Guidelines for Outdoor Developed Areas 1017.11</i>	➤ At such time the trailhead sign is replaced, provide additional information about the characteristics of the trail.	3	Long term

6. APIS Otter Island. View of vault toilet. The toilet does not currently provide any features of accessibility.

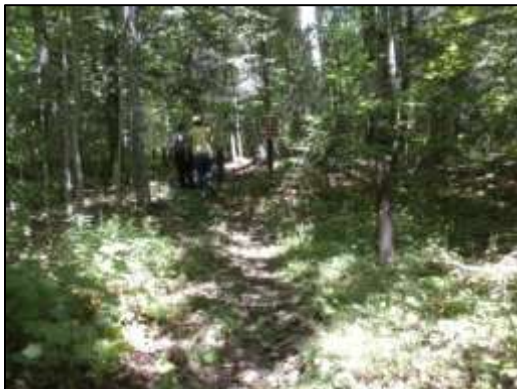
7. APIS Otter Island. View of trail. The trail is located in the Gaylord Nelson Wilderness.

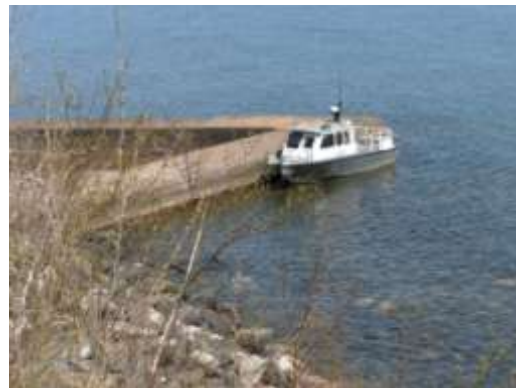
2. APIS Outer Island. Dock.

Item	Deficiency	<input type="checkbox"/> Possible Solutions (recommended action indicated by: ►)	Barrier Level	Timeframe
Dock: <i>The dock is located at the north end of Outer Island. The dock is currently 300' long (approximately 60' closest to the steps and 80' near the end of the dock are usable) the dock is usable on one side only.</i> National Register of Historic Places				
Dock	There are currently vertical changes in level up to 4" where the sections of concrete come together. <i>ABA 1003.2, 401</i>	► Repair the dock to eliminate the 4" vertical change.	2	Long term
Light Station: National Register of Historic Places				
Light Station-Route	The route around the light station is currently concrete slab. The slabs of concrete connecting the Fog Signal building to the Tower and Keepers Quarters are 30" wide by 48" long. <i>ABA 403.5.1</i>	<input type="checkbox"/> Remove and replace the concrete slabs with a firm, stable, slip resistant surface that is 36" wide minimum. ► Add additional width to concrete slabs by adding new precast units adjacent to existing to achieve an accessible width.	3	Long term

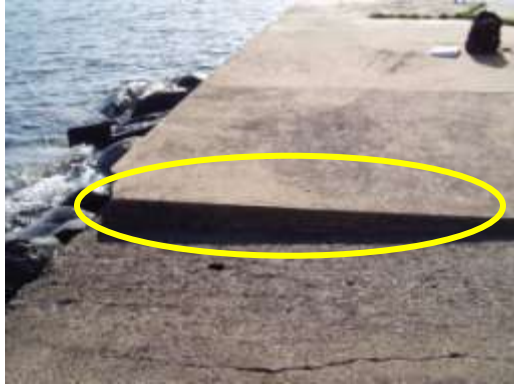
3. APIS Outer Island. Dock. Abrupt changes in level (up to 4") where sections of concrete come together.

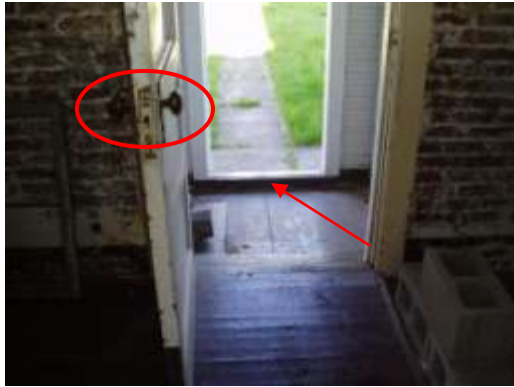
9. APIS Outer Island. Tower and Keepers Quarters. View of kitchen entry from interior. Note knob style hardware and lip at the vestibule.

Tower and Keepers Quarters-Entry	There is currently a 4" vertical rise at the threshold of the vestibule entry. <i>ABA 404.2.5</i>	➤ Address the vertical rise at such time a ramp is added.	3	Long term
Tower and Keepers Quarters-Entry	The clear opening of vestibule is currently 31" (door has been removed). <i>ABA 404.2.3</i>	<input type="checkbox"/> Remove and replace the door with a style that provides a 32" minimum clear opening. ➤ No action at this time, 31" is considered 'usable by' the majority of individuals with disabilities.	3	Long term
Tower and Keepers Quarters-Door Hardware	The operable door hardware at the kitchen is currently a knob style. <i>ABA 309.4</i>	<input type="checkbox"/> Replace the knob style hardware with a style that does not require tight grasping, pinching or twisting of the wrist to operate (such as a lever). ➤ No action at this time, the building is not currently occupied.	2	Long term

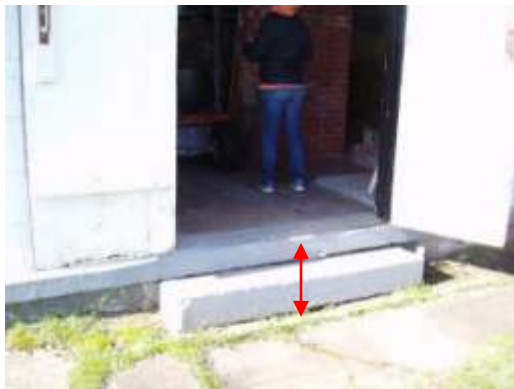
11. APIS Outer Island. Fog Signal Building. View of main entry.

Fog Signal Building National Register of Historic Places				
Fog Signal-Entry	There is currently a 14" rise at the entry. <i>ABA F206, 303</i>	<input type="checkbox"/> Construct a ramp with a 1:12 maximum slope. Include required handrails and edge protection. <input type="checkbox"/> Construct a 'ramp' with a 1:20 maximum slope. ➤ No action at this time, this building is not currently occupied.	1	Long term
Fog Signal-Entry	A single leaf of the double door currently provides a 28 1/2" clear opening. <i>ABA 404.2.3</i>	<input type="checkbox"/> Remove and replace the doors with a style that provides a single leaf with a 32" minimum clear opening. ➤ No action at this time, opening both doors provides a 32" clear opening.	3	Long term
Fog Signal-Entry	There is currently a 1 1/2" rise at the threshold of the entry vestibule. <i>ABA 404.2.5</i>	<input type="checkbox"/> Address the rise at such time a ramp is added. ➤ No action at this time, this building is not currently occupied.	2	Long term

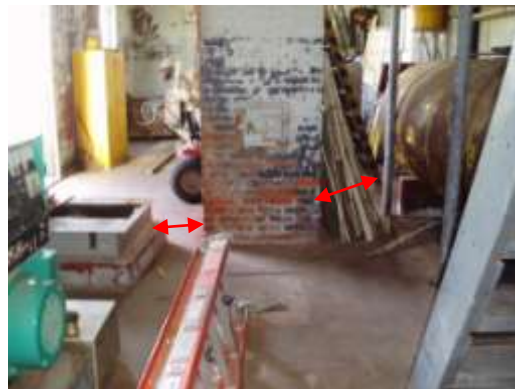
12. APIS Outer Island. Fog Signal Building. There is not currently an interior accessible route.

Fog Signal-Interior	There is not currently an interior accessible route. The positioning of permanent equipment and structural columns reduces the clear width to less than 32" at multiple locations. <i>ABA 403.5</i>	➤ No action at this time, this building is not currently occupied.	2	Long term
Vault Toilet- Light Station				
Vault Toilet	The vault toilet does not currently provide any features of accessibility.	➤ Replace the existing vault toilet with an accessible style. <input type="checkbox"/> Add an additional, accessible vault toilet.	1	Long term
Vault Toilet-Route	There is not currently an accessible route to the vault toilet. <i>ABA F206.2</i>	➤ Create an accessible route to the vault toilet.	2	Long term

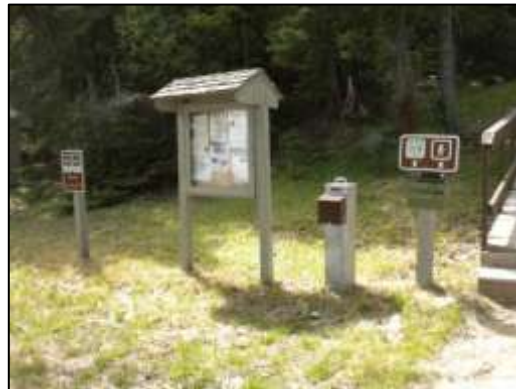
2. APIS Rocky Island. View of wayside and fee station. Stairs to the new vault toilets visible on the right side of the photo.

Item	Deficiency	<input type="checkbox"/> Possible Solutions (recommended action indicated by: ►)	Barrier Level	Timeframe
Fee Station and Waysides	There is a fee station and bulletin case located in the grass at the end of the dock. <i>ABA 302</i>	► Add an accessible route and approach to the fee station. <input type="checkbox"/> Relocate the fee station to an accessible location (possibly the dock).	3	Short term
Trailhead Sign	The sign at the trailhead does not currently include information about the characteristics (width, slope, cross slope, etc.) of the trail. <i>Draft Accessibility Guidelines for outdoor Developed Areas 1017.11</i>	► At such time the trailhead sign is replaced, provide additional information about the characteristics of the trail.	3	Long term
Picnic Area	A picnic area with 3 picnic tables, grill and fire ring is located in the grass near the end of the dock. The picnic tables do not currently provide knee and toe clearance. <i>Draft Accessibility Guidelines for Outdoor Developed Areas 1011.4</i>	<input type="checkbox"/> Add an accessible picnic table at an accessible location. ► Replace the existing picnic table with a style that provides knee and toe clearance and is located on an Outdoor Recreation Access Route (ORAR).	2	Short term

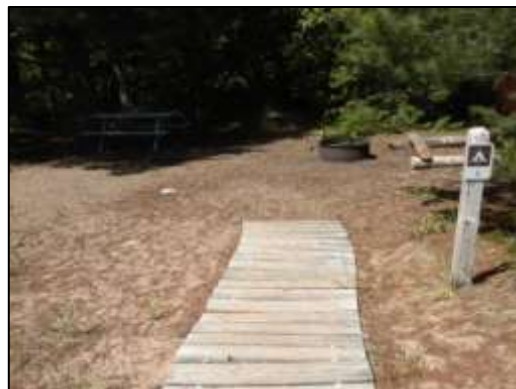
6. APIS Rocky Island. Campsite 1 provides direct access from the beach.

Campsite route- 1	Campsite 1 is accessed primarily from the beach. A section of 32" wide boardwalk has been provided. <i>Draft Accessibility Guidelines for Outdoor Developed Areas 1016.3</i>	► At such time the boardwalk is replaced or if additional segments of boardwalk are added, ensure it is 36" wide minimum.	2	Long term
Campsite 1	A picnic table, fire ring and bear locker are provided at the campsite. The picnic table does not currently provide knee and toe clearance. <i>Draft Accessibility Guidelines for Outdoor Developed Areas 1011.4</i>	<input type="checkbox"/> Replace the existing picnic table with a style that provides knee and toe clearance. ► No action at this location. Provide accessible camping at an alternate location.	2	Short term
Campsite route- 2-3	Campsites 2-3 are located off of a trail to the south of the dock. The trail surface is currently uneven and overgrown. <i>Draft Accessibility Guidelines for Outdoor Developed Areas 1017</i>	<input type="checkbox"/> Create an accessible trail to the campsites. ► No action at this location. Provide accessible camping at an alternate location.	3	Long term

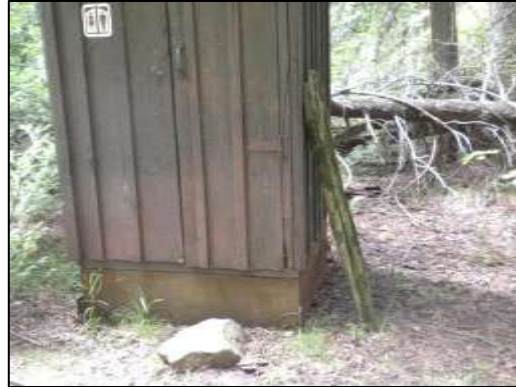
8. APIS Rocky Island. View of typical vault toilet.

Vault toilet-campsites 1-3	The existing vault toilet does not currently provide any features of accessibility. It is 43" wide x 46" deep and provides a 19" clear door opening. <i>ABA F213.2</i>	➤ Replace the existing vault toilet with an accessible style. <input type="checkbox"/> Add an additional accessible vault toilet.	2	Long term

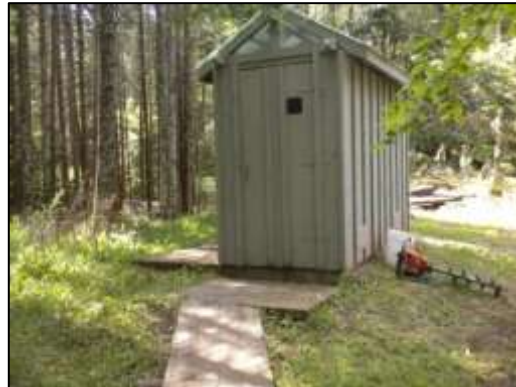
10. APIS Rocky Island. View of the double vault toilet serving picnic and dock area. These vault toilets will be removed once the new ones are installed.

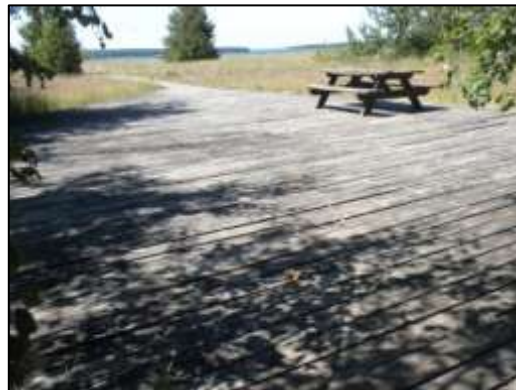
4. APIS South Twin Island. View of the picnic area located at the end of the boardwalk. The picnic table does not provide knee and toe clearance.

Campsites	A picnic table, fire ring and bear locker are provided at each of the 4 campsites. The picnic tables do not currently provide knee and toe clearance. <i>Draft Accessibility Guidelines for Outdoor Developed Areas 1011.4</i>	➤ Replace the existing picnic table with a style that provides knee and toe clearance at campsite 1.	2	Short term
Campsite	The surface within the campsites is mostly flat with some tree roots and rocks within the circulation space. <i>Draft Accessibility Guidelines for Outdoor Developed Areas F244.5</i>	➤ Clear the tree roots and rocks from the ground surface within campsite 1 to create a firm, stable surface.	2	Short term
Vault toilets	There are 5 vault toilets (1 single, 2 doubles). The existing vault toilets do not currently provide any features of accessibility. They are approximately 38" wide x 48" deep and provides a 25" clear door opening. <i>ABA F213.2</i>	➤ Replace 1 of the existing vault toilets with an accessible style (recommended at the south, single location near campsite 1). <input type="checkbox"/> Add an additional accessible vault toilet at a location served by an Outdoor Recreation Access Route (ORAR).	2	Long term

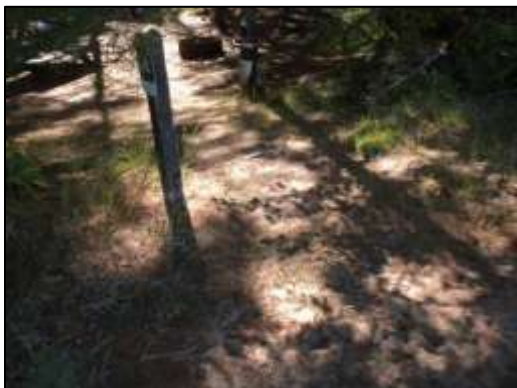
5. APIS South Twin Island. Route to campsite 1 from the boardwalk. The route is short and flat but does not currently have a firm and stable surface.

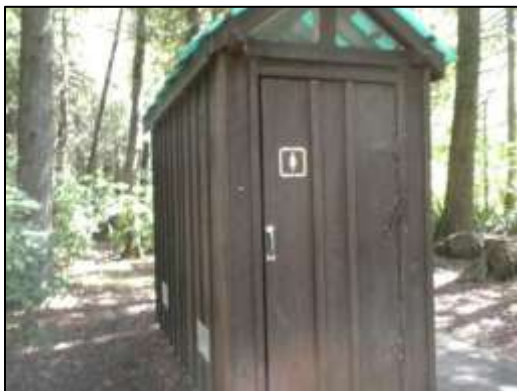
10. APIS South Twin Island. Interior view of typical vault toilet.

Vault toilets-route	There are currently vertical rises ranging from 2" - 6" from the ground surface up to the vault toilets. <i>Draft Accessibility Guidelines for Outdoor Developed Areas 1016.5</i>	<input type="checkbox"/> Add a ramp to eliminate the 6" rise at the south location near campsite 1. <input type="checkbox"/> Build up the ground material around the vault toilet to eliminate the 6" rise at the south location near campsite 1. ➤ At such time the vault toilet is replaced, ensure there is no vertical rise.		Long term
Vault toilet-route	There is not currently an accessible route to any of the vault toilets. The location near campsite 1 is the closest to the existing boardwalk and has minimal grade change. <i>ABA F206.2</i>	<input type="checkbox"/> Create an accessible route to the vault toilet. ➤ At such time the vault toilet is replaced, ensure an accessible route is provided.		Long term

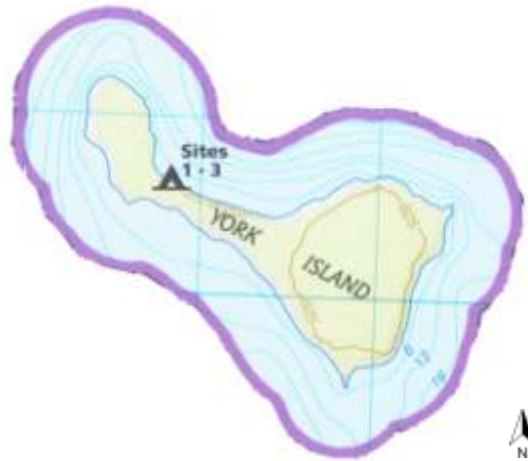
Item	Deficiency	<input type="checkbox"/> Possible Solutions (recommended action indicated by: ►)	Barrier Level	Timeframe
Campsite routes	A short section of boardwalk has been provided from the sand beach directly in to each of the 3 campsites. The boardwalk is 32" wide at site 3 and 36" wide at sites 1 and 2. <i>Draft Accessibility Guidelines for Outdoor Developed Areas 1016.3</i>	<input type="checkbox"/> At such time the boardwalk is replaced or if additional segments of boardwalk are added, ensure it is 36" wide minimum. ► No action. The boardwalk is located within the Gaylord Nelson Wilderness.	2	Long term
Campsites	A fire ring and bear locker are the only amenities provided at the 3 campsites.	► No action. The campsites are located within the Gaylord Nelson Wilderness.	2	Long term
Vault toilet	The existing vault toilet does not currently provide any features of accessibility. It is 40 1/2" wide x 52" deep and provides a 21" clear door opening. <i>ABA F213.2</i>	► Replace the existing vault toilet with an accessible style. <input type="checkbox"/> Add an additional accessible vault toilet. <input type="checkbox"/> No action. This vault toilet is located within the Gaylord Nelson Wilderness.	1	Long term

1. APIS York Island. View of route to campsite 2 (routes to sites 1 and 3 are similar).

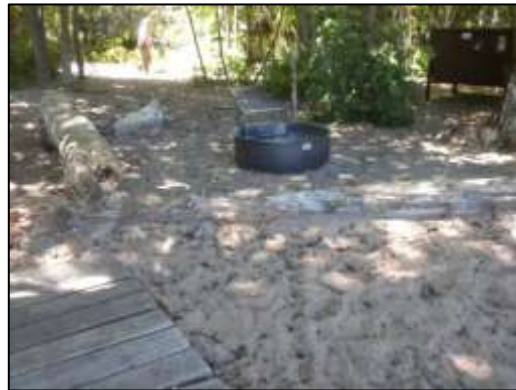
2. APIS York Island. View of campsite. Amenities include fire ring and bear locker. The surface within the campsite is sand.

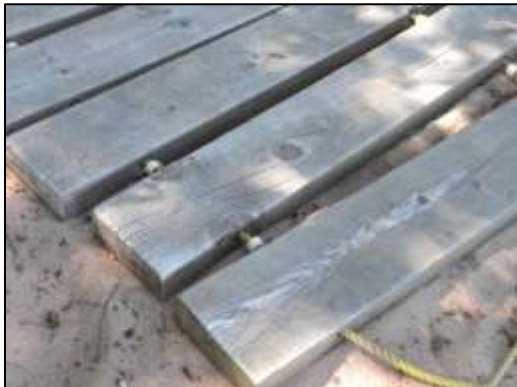
3. APIS York Island. View of boardwalk system.

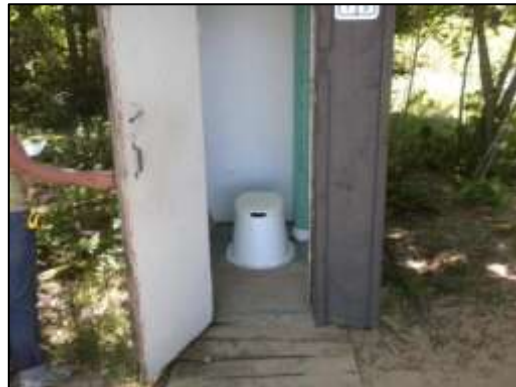
Vault toilet-route	There is not currently an accessible route to the vault toilet. The current route is sand and segments of 32" wide boardwalk. <i>ABA F206.2</i>	<input type="checkbox"/> Create an accessible route to the vault toilet. ➤ No action. This vault toilet is located within the Gaylord Nelson Wilderness.	1	Long term
--------------------	--	---	---	-----------

4. APIS York Island. View of vault toilet. No features of accessibility provided at this time.

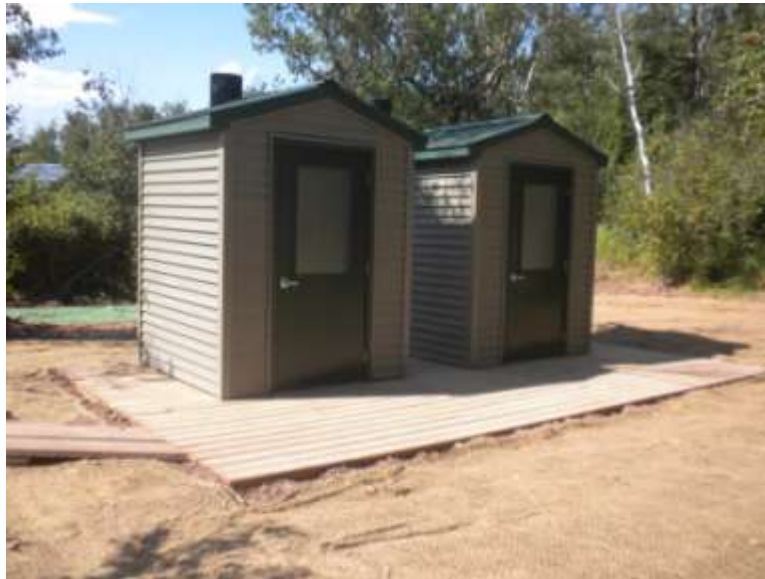
Deficiency: Vault Toilet Accessibility

Action Taken: 2 of the vault toilets were replaced with an accessible model
